**SECTION 13-G
ESTATE WAGON BODY SERVICE**

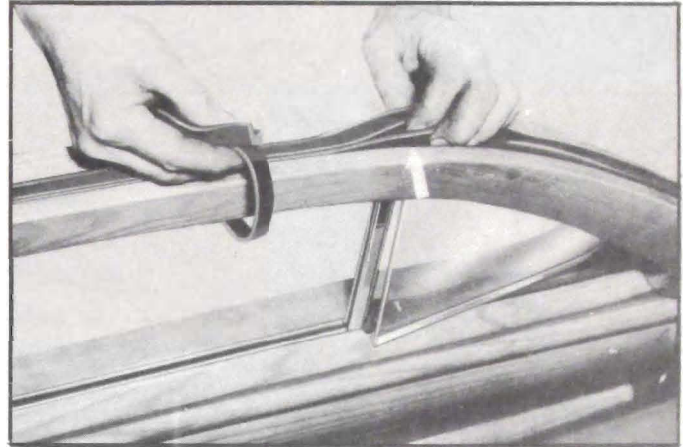
place. The weatherstrip space between flange of door and the body is $\frac{3}{8}$ " , which will permit weatherstrip to firmly contact the body when door is closed. If this space is greater than $\frac{3}{8}$ " so that weatherstrip does not contact body, correction may be made by loosening weatherstrip from door flange and inserting a $\frac{1}{8}$ " x $\frac{1}{2}$ " sponge rubber strip of required length, with rubber parts firmly cemented to door. See figure 13-82.

Figure 13-82—Placing Rubber Strip Behind Door Weatherstrip

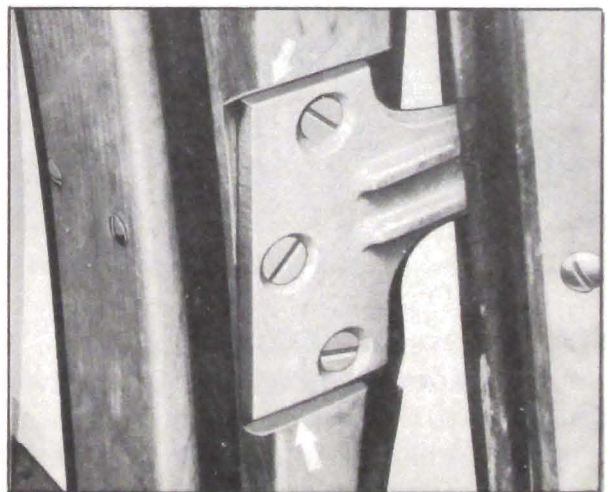
Leakage will occur at rear door upper and lower hinges if the hinge cut-outs in the hinge pillars are excessively wide. See figure 13-83. To correct, fill the cut-out above and below the hinge with a high grade heavy body plastic putty.

Figure 13-83—Points of Leakage at Rear Door Hinges—Lower Hinge Shown

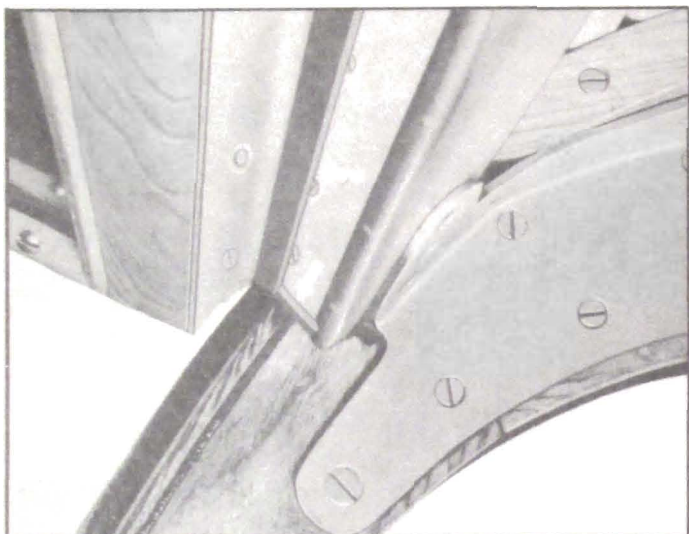
Lift gate leaks can be corrected by cementing $\frac{1}{8}$ " x $\frac{1}{2}$ " sponge rubber strips across the inside of the hinge against the hinge pin and at each end of the lift gate header bar against the corner posts. See figure 13-84.

Figure 13-84—Sponge Rubber Strips Installed at Lift Gate Hinge

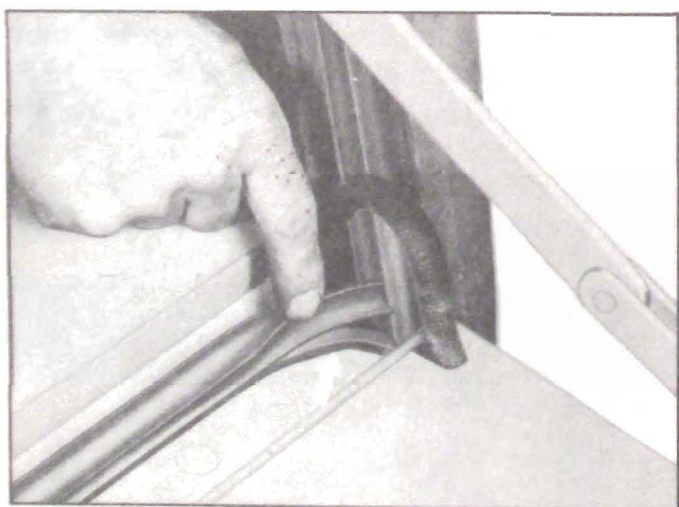
Leaks into the tire compartment through the tail light wire holes may be corrected by filling under the rear floor end scuff plate weatherstrip with a $\frac{1}{8}$ " x $\frac{1}{2}$ " sponge rubber strip when clearance is greater than $\frac{3}{8}$ ". See figure 13-85.

Figure 13-85—Point of Leakage into Tire Compartment

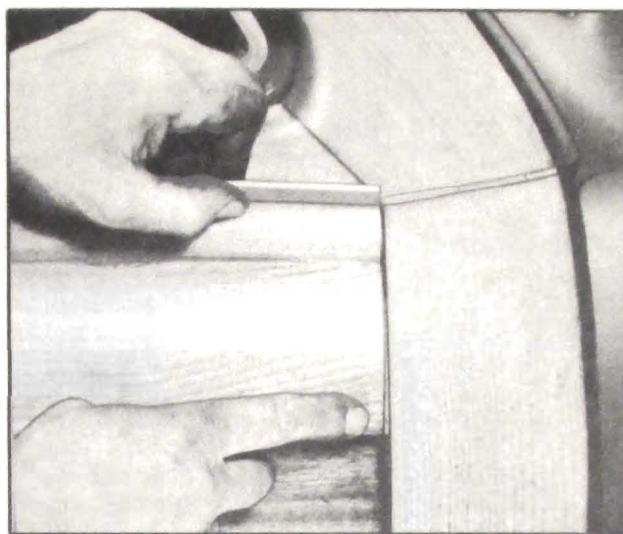
Figure 13-86—Filling Cracks at Joints

oughly cleaned out and filled by a wood shim glued in place. See figure 13-86.
