### 5-10 DYNAFLOW OPERATIONAL FAULTS, CAUSES AND CORRECTIONS

## **5-12 DYNAFLOW MANUAL CONTROL MECHANISM AND LINKAGE ADJUSTMENTS**

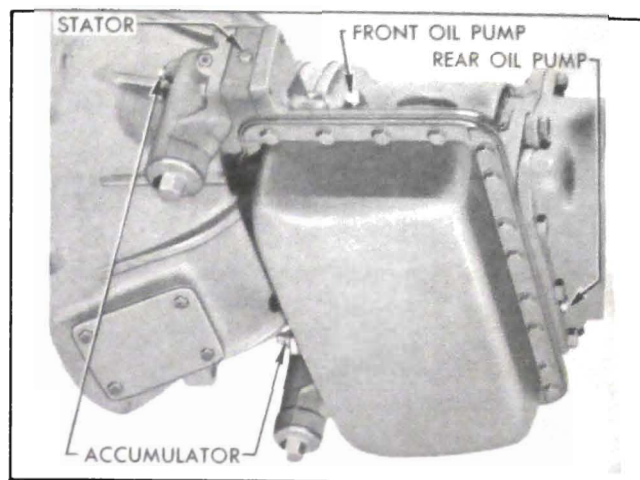
Figure 5-23—Gauge Connections for Oil Pressure Tests

Remove pipe plug at the following points in turn and connect Pressure Gauge J 2575. (1) *Front oil pump*, on left side of transmission case. (2) *Rear oil pump*, in lower flange at front end of rear bearing retainer. (3) *High or low accumulator*, on front upper corner of accumulator body. (4) *Stator*, on left end of reaction shaft flange. See figure 5-23.

Run engine at 500 RPM and test pump and accumulator pressures in Low, Drive and Reverse. Test front oil pump in all ranges and rear oil pump in all but Reverse. Test high accumulator only in Drive and test low accumulator only in Low. Repeat tests at 1000 RPM and 1800 RPM in Low and Drive only. The following pressures should be obtained on these tests.

Engine RPM	Trans. Range	Front Pump	Rear Pump	Accumulator	Stator
500	Low	120	90	115	—
	Drive	90	90	80	70
	Reverse	120	—	—	—
1000	Low	180	180	175	—
	Drive	90	90	85	75
1800	Low	180	180	175	—
	Drive	90	90	85	75

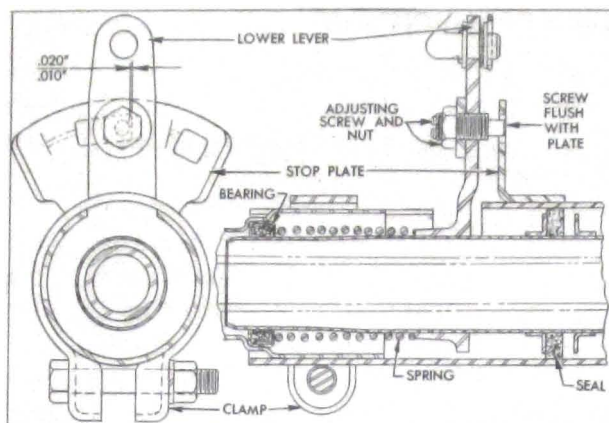
Figure 5-24—Lower Lever and Stop Plate

1. With shift control lever released, the stop screw in control shaft lower lever must be flush ( $\pm .010''$ ) with upper surface of stop plate. Adjust as required. See figure 5-24.

2. With shift control lever in Drive position, .010" to .020" clearance must exist between the stop screw and the upper edge of large opening in stop plate. See figure 5-24. Since this clearance cannot be readily checked because of location, it may be assured by carefully performing the following adjustment.
