## SECTION 5-B

TWIN TURBINE TRANSMISSION TROUBLE DIAGNOSIS—  
ADJUSTMENTS ON CAR

5-9 TWIN TURBINE TRANSMISSION  
TEST AND INSPECTION

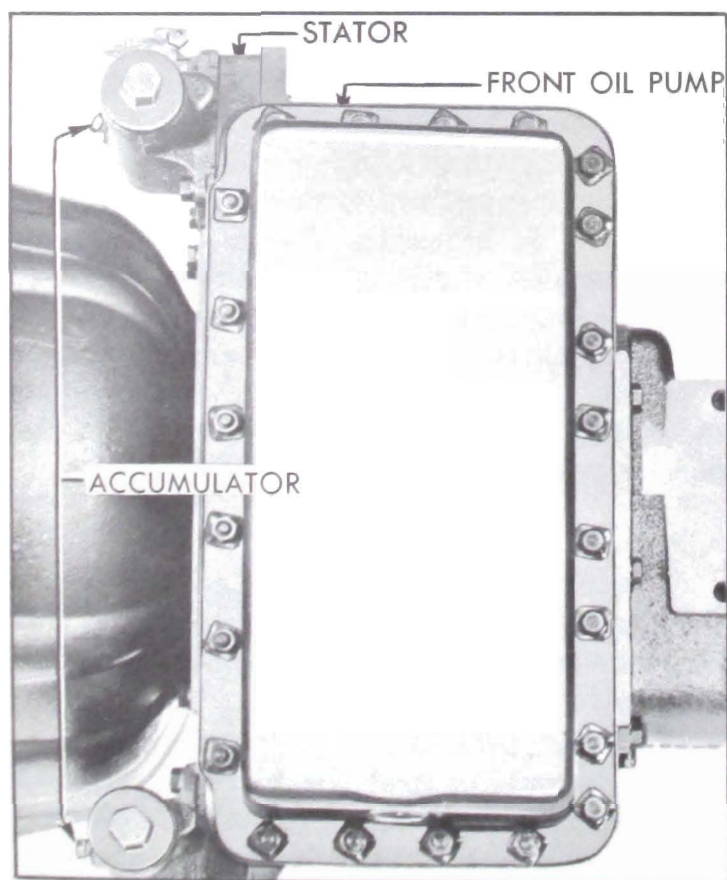
Remove pipe plug at the following points in turn and connect Pressure Gauge J 2575. (1) *Front oil pump*, on left side of transmission case. (2) *High or low accumulator*, on front upper corner of accumulator body. (3) *Stator*, on left end of reaction shaft flange. See figure 5-26.

Figure 5-26—Gauge Connections for Oil Pressure Tests

Run engine at 500 RPM and test pump and accumulator pressures in Low, Drive and Reverse. Test front oil pump in all ranges. Test high accumulator only in Drive and test low accumulator only in Low. Repeat tests at 1000 RPM and 1800 RPM in Low and Drive only. The following pressures should be obtained on these tests.

Engine RPM	Trans. Range	Front Pump	Accumulator	Stator (min.)
500	Low	120	115	—
	Drive	90	80	10
	Reverse	120	—	—
1000	Low	180	175	—
	Drive	90	85	70
1800	Low	180	175	—
	Drive	90	85	75

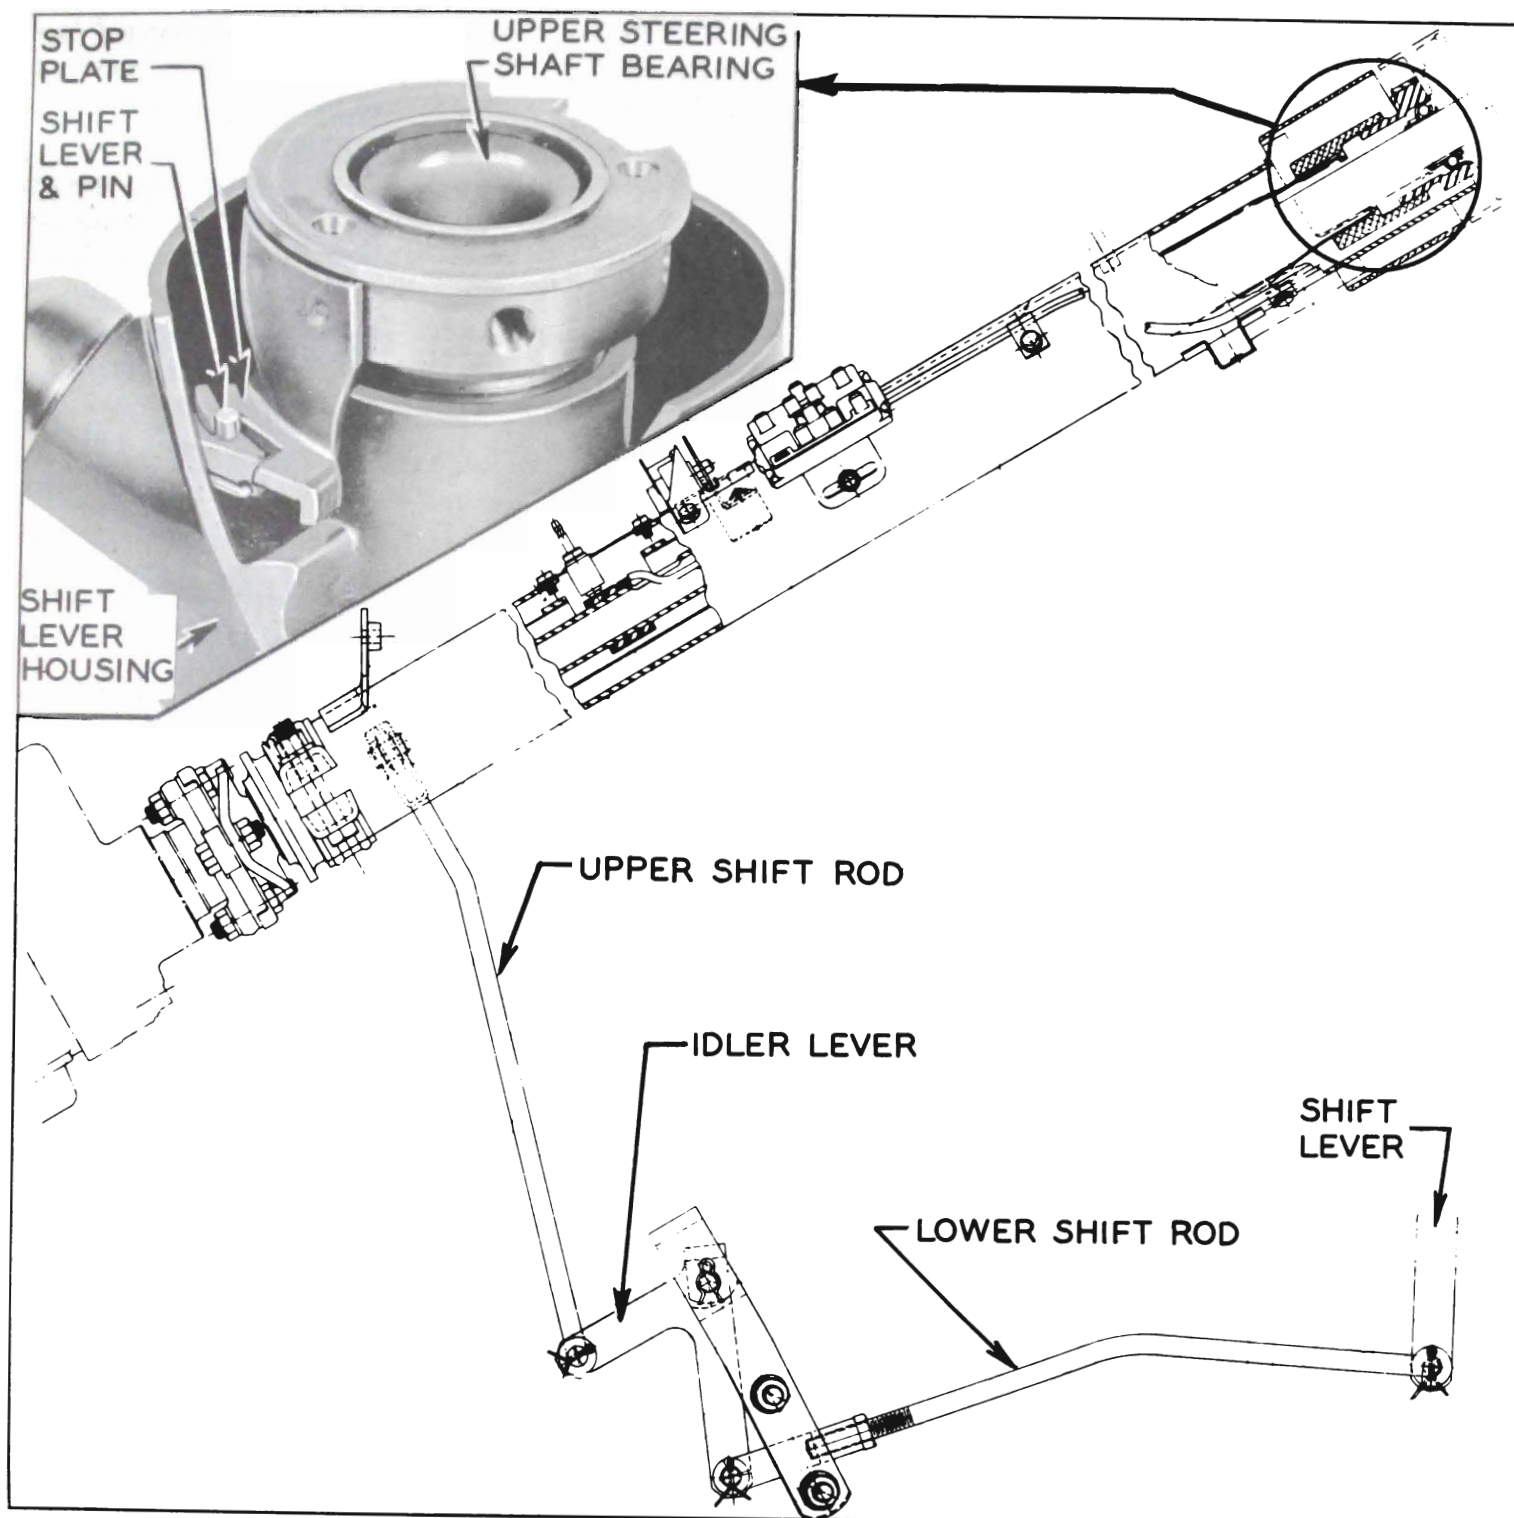
Figure 5-27—Shift Linkage, Lever and Stop Plate

When a Twin Turbine transmission does not operate properly it is advisable to first check the shift control linkage adjustment, *after checking to be sure oil is at proper level.* The

shift control linkage may be easily checked as follows:
