SECTION 5-B

TWIN TURBINE TRANSMISSION TROUBLE DIAGNOSIS—

ADJUSTMENTS ON CAR

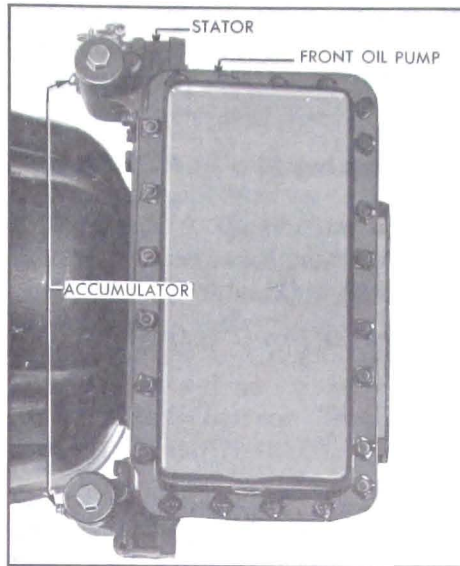
Figure 5-26—Gauge Connections for Oil Pressure Tests

Remove pipe plug at the following points in turn and connect Pressure Gauge J-2575. (1) Front oil pump, on left side of transmission case. (2) High or low accumulator, on front upper corner of accumulator body. (3) Stator, on left end of reaction shaft flange. See Figure 5-26.

Run engine at 500 RPM and test pump and accumulator pressures in Low, Drive and Reverse. Test front oil pump in all ranges. Test high accumulator only in Drive and test low accumulator only in Low. Repeat tests at 1000 RPM and 1800 RPM in Low and Drive only. The following pressures should be obtained on these tests.

Engine RPM	Trans. Range	Front Pump	Accumulator	Stator (min.)
500	Low	120	115	10
	Drive	90	80	10
	Reverse	120	-	-
1000	Low	180	175	65
	Drive	90	85	65
1800	Low	180	175	75
	Drive	90	85	75

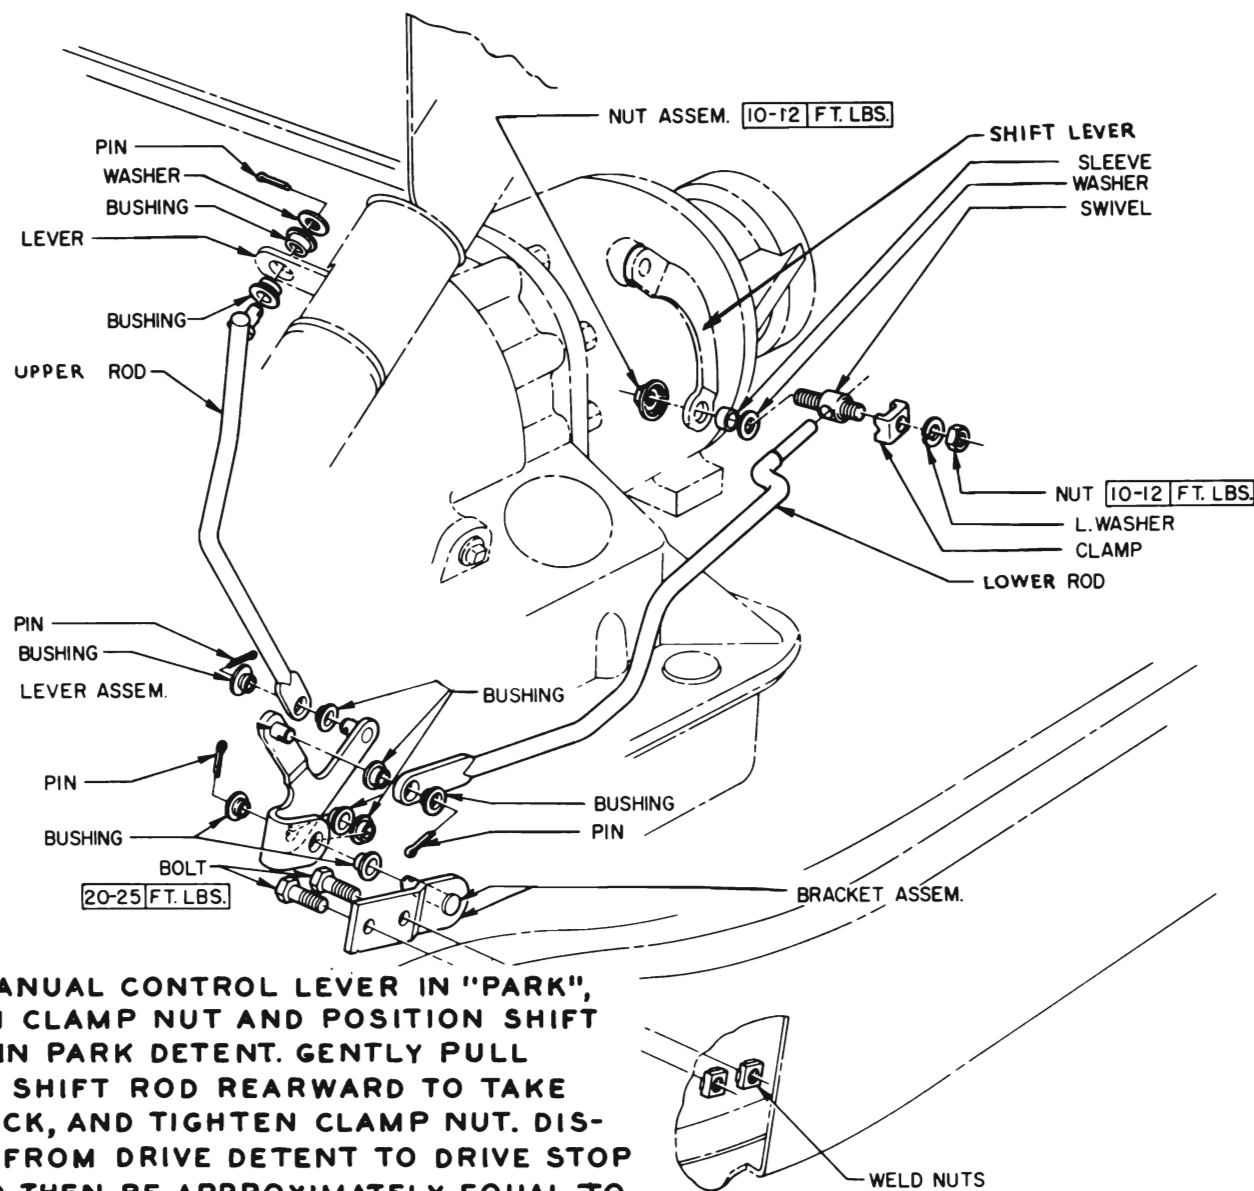
Figure 5-27—Shift Linkage

WITH MANUAL CONTROL LEVER IN "PARK", LOOSEN CLAMP NUT AND POSITION SHIFT LEVER IN PARK DETENT. GENTLY PULL LOWER SHIFT ROD REARWARD TO TAKE UP SLACK, AND TIGHTEN CLAMP NUT. DISTANCE FROM DRIVE DETENT TO DRIVE STOP SHOULD THEN BE APPROXIMATELY EQUAL TO DISTANCE FROM LOW DETENT TO LOW STOP.

1. With manual control lever in Park position, raise car to allow access to lower linkage.
2. Loosen clamp nut at lower end of upper rod. Move lever several times to be certain lever is in "Park" detent.
3. Tighten clamp nut.

4. Check adjustment. Distance from drive detent to drive stop should be approximately equal to distance from low detent to low stop.
