GROUP 5 REAR AXLE ASSEMBLY

5-1 REAR AXLE CHANGES

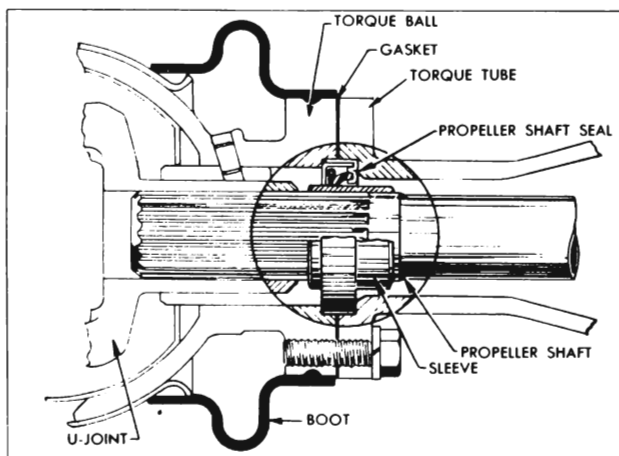
The seal is installed with the spring loaded lip edge toward front of car, and this edge bears against a sleeve which is pressed on the propeller shaft in position to close off the splines against passage of oil. A paper gasket is used between the torque tube and torque ball.

Figure 5-1—Propeller Shaft Seal

A new propeller shaft seal was used at start of 1953 production. The new seal is tightly fitted into a recess in the torque tube front flange. Approximately half of the seal retainer projects into a recess in the torque ball to act as a pilot. The universal joint seal formerly located at this point in torque ball has been eliminated. See figure 5-1.

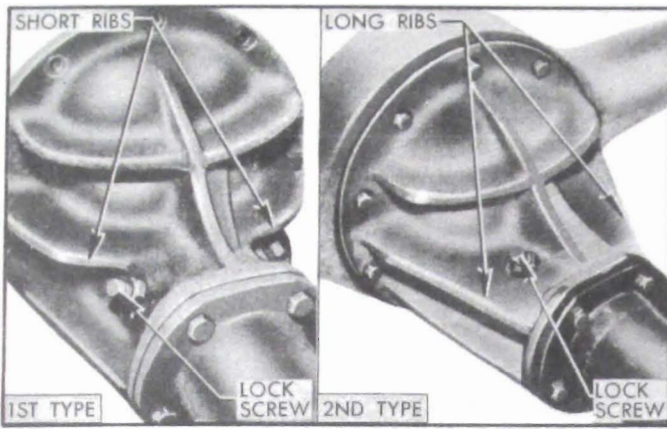
Figure 5-2—First and Second Type Differential Carriers

First and second differential designs may be identified by the external appearance of the carriers. In the second type, the upper side ribs are extended forward to the front flange and the pinion bearing sleeve lock screws are rotated so that the bottom screw is no longer straight down. See figure 5-2.

After 1953 production started, a new differential, propeller shaft, and third member housing assembly was introduced on all models. The change permits use of larger pinions to provide faster rear axle gear ratios. While the second design is essentially the same as the first, none of the parts are interchangeable because of differences in dimensions. At the same time this change was made, the speedometer driving worm gear was changed to 8 teeth (par. 4-1, e).

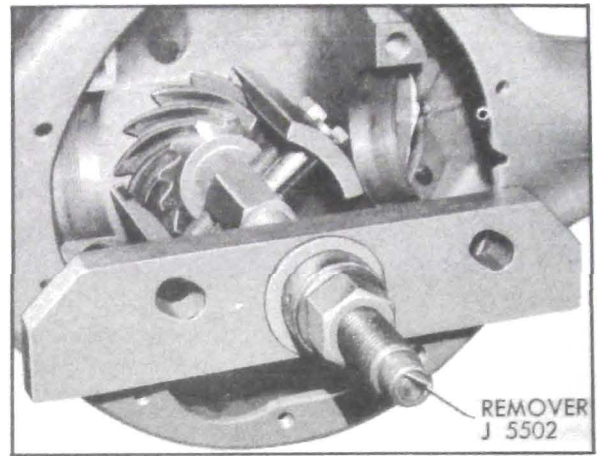
Figure 5-3—Removing Pinion and Shaft

Remover and Replacer J 5502 is designed to pull the pinion and shaft assembly as shown in figure 5-3. Since it is definitely recommended that the assembly be pressed and not driven during installation, this tool is also designed to press the assembly into place as shown in figure 5-4.

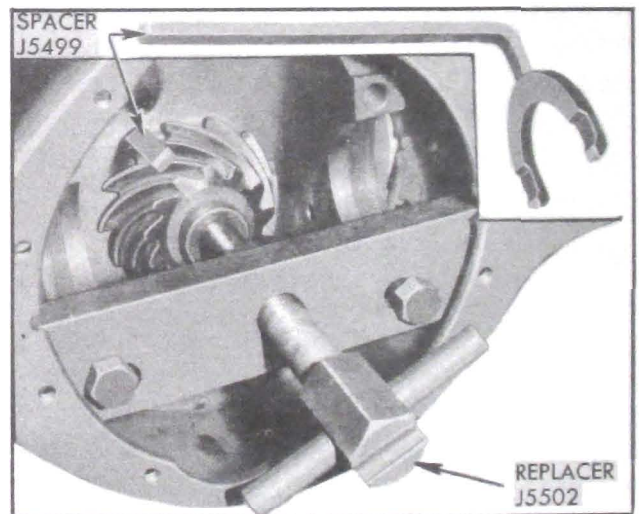
Figure 5-4—Pressing Pinion and Shaft into Place

Because of the increased diameter of the second type pinion gear, a new Pinion Bearing Spacer J 5499 must be inserted between the rear bearing and the pinion gear during installation so that the bearing will be pushed into place without binding against the spacer on pinion shaft. See figure 5-4.

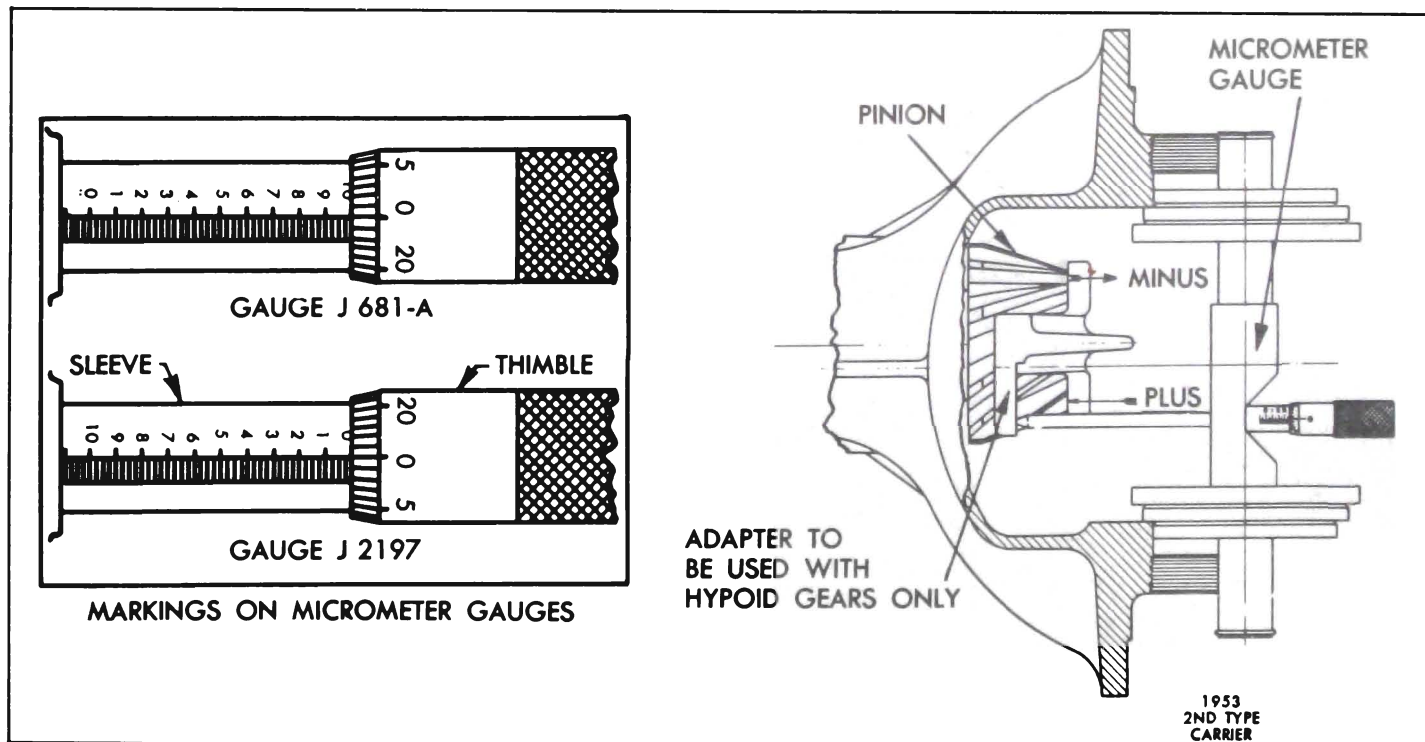
PINION SETTING TABLE FOR GAUGE J 681-A

PINION SETTING TABLE FOR GAUGE J 2197

Figure 5-5—Pinion Setting Tables for Second Type Carrier

(2) *Second Type Carrier.* When checking pinion setting in the second type carrier use the new Adapter J 2197-9 with Clamp J 2197-8 and also use the new pinion setting table given in

figure 5-5 of this manual. The new table is based on a nominal setting of .317 for Gauge J 681-A and .864 for Gauge J 2197.
