GROUP 12

SHEET METAL

12-1 DESCRIPTION OF SHEET METAL

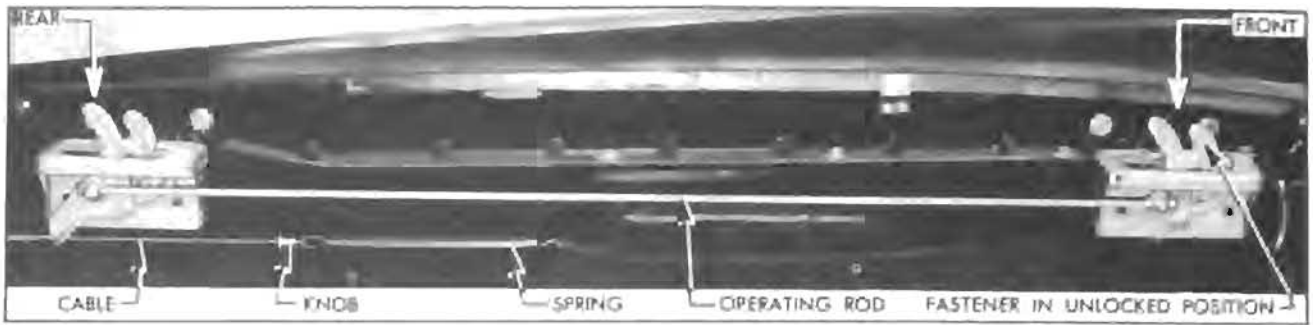
Figure 12-1—Hood Hinges and Fastener Mechanism

The hood fastener mechanism is incorporated in the hood hinges. A hood fastener mounted in each hinge engages the hood reinforcement pilot

plate when hood is lowered, and as side of hood is pressed down the fasteners rotate to securely lock the hood to the hinges. A pilot pin on reinforcement pilot plate engages a hole in each hinge pilot plate to hold the hood in proper relation to fenders and cowl.

When either side of hood is to be unlocked the hood fastener mechanism is operated by a cable attached to a control knob located inside the body at lower edge of instrument panel. The forward end of release cable is connected to a coil spring attached to fender skirt; the spring holds the cable and knob in forward position. When knob is pulled rearward to unlock hood, a knob on end of cable pushes against an arm of rear hinge fastener to rotate fastener to the unlocked position. The front hinge fastener is rotated to unlocked position by a rod which connects the front and rear fasteners. See figure 12-1.

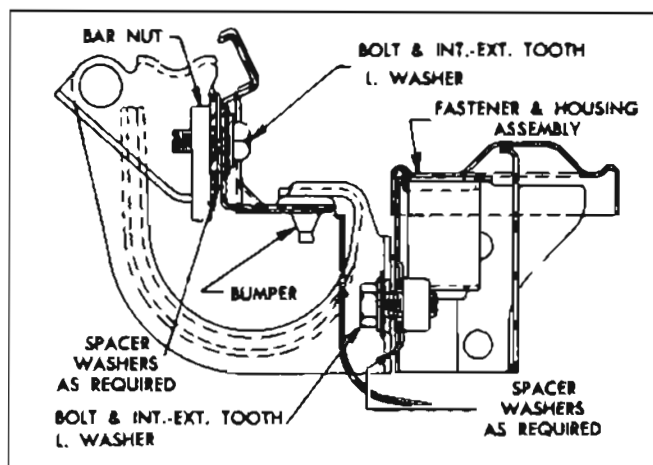
Figure 12-2—Hood Hinge Mounting

The hinge fastener and housing assembly is bolted to the gooseneck hinge strap and the bolt holes in strap are slotted to permit vertical adjustment of the fastener housing only. See figure 12-2. This arrangement permits vertical adjustment without changing the pivot point of the hinge, and without changing the fore and aft setting.

Lateral adjustment of hinge to change hood-to-fender clearance is obtained by U-shaped spacer washers which can be removed or installed without removing hinge bolts. These washers are furnished under Group 8.014 in thicknesses of .030" and .120".

To move hinge fastener and housing assembly outward to decrease hood-to-fender clearance, either remove spacer washers from between fastener housing and hinge strap or install washers between hinge mounting bracket and fender rail. To move parts inward to increase clearance, either remove spacer washers from between hinge mounting bracket and fender rail or install washers between hinge strap and fastener housing. See figure 12-2. An equal total thickness of washers must be used on both bolts at either point of adjustment.

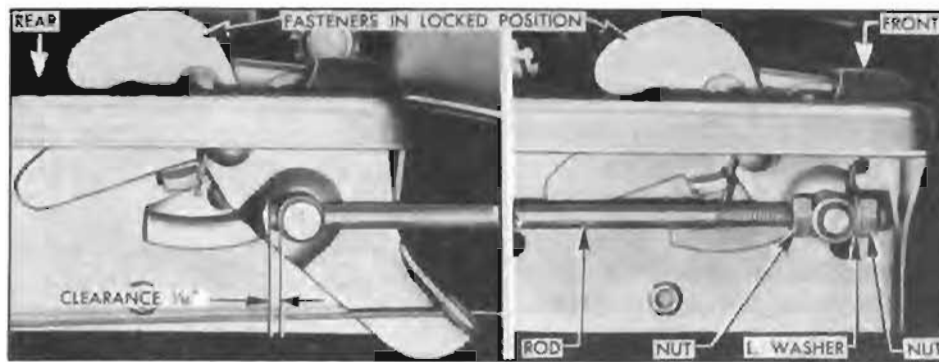
Figure 12-3—Adjustment of Hood Fastener Operating Rod

with holes in hinge pilot plates. Push both fasteners down to the locked position and have both hinges resting on bumpers on fender rail. Check the clearance between the shoulder on rear end of operating rod and the trunnion of rear fastener; clearance should be approximately $\frac{1}{16}$ ". Adjust the nuts on each side of front fastener trunnion to obtain this clearance, if necessary. See figure 12-3.

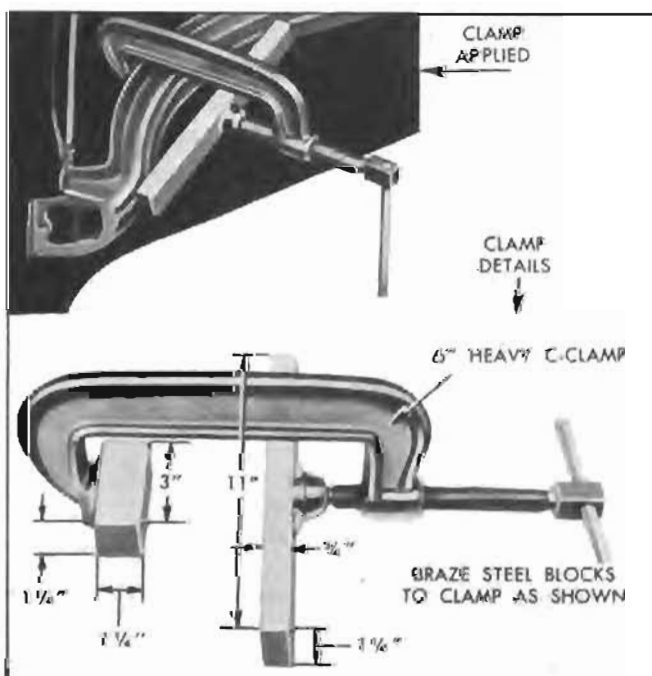
Figure 12-4—Straightening Hood Panel Reinforcement to Spread Hood

The hood may be made wider by straightening the reinforcement with a C-clamp prepared and applied as shown in figure 12-4. The hood may be reduced in width by bending the reinforcement with a large turnbuckle prepared and applied as shown in figure 12-5. Both tools illustrated may be made locally from details shown.

The hood panel reinforcements are of channel section and welded to hood side rails to provide an assembly of fixed width at all points. Adjustment for width should not be necessary except when hood has been distorted due to accident. If alteration of hood width becomes necessary,

however, it may be accomplished by carefully bending the reinforcements with proper tools.

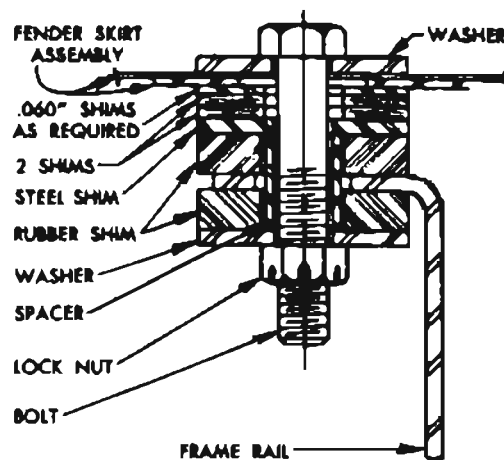
Figure 12-6—Fender Skirt Bolt and Shims

At the point where each front fender skirt is attached to the frame front end a rubber shim is placed on each side of the frame rail top flange, with a steel washer, $\frac{1}{8}$ " steel shim and

tubular spacer placed to control compression of the rubber shims as the bolt is tightened. Two steelbestos shims are placed between the $\frac{1}{8}$ " steel shim and the fender skirt. When additional shimming is required one or more extra steel shims .060" thick are placed between the steelbestos shims and the fender skirt. See figure 12-6.

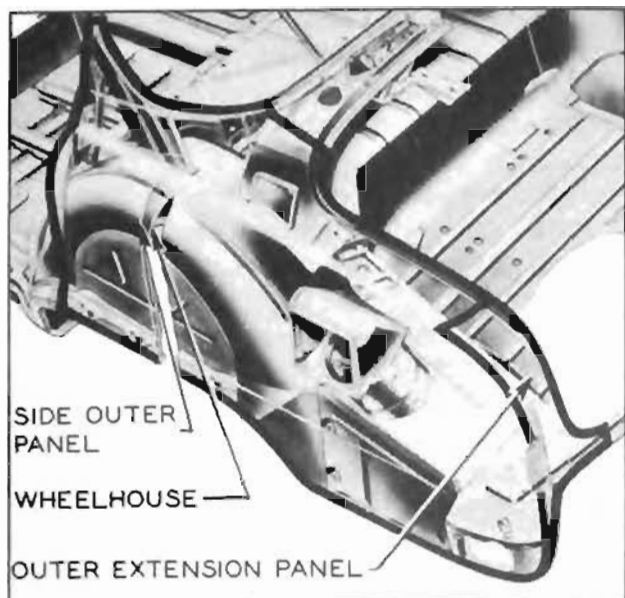
Figure 12-7—Rear Quarter Side Outer Panel Assembly—
Series 40

Series 40 rear fenders are incorporated in the body rear quarter side outer panel assemblies. A panel assembly includes the rear quarter side outer panel, wheelhouse, gas tank filler cover (left side), side outer extension

panel, and miscellaneous small parts all welded together. See figure 12-7.

The rear quarter side outer panel does not include the area covered by the side outer extension panel shown in figure 12-7. The extension panel is also available for service replacement.

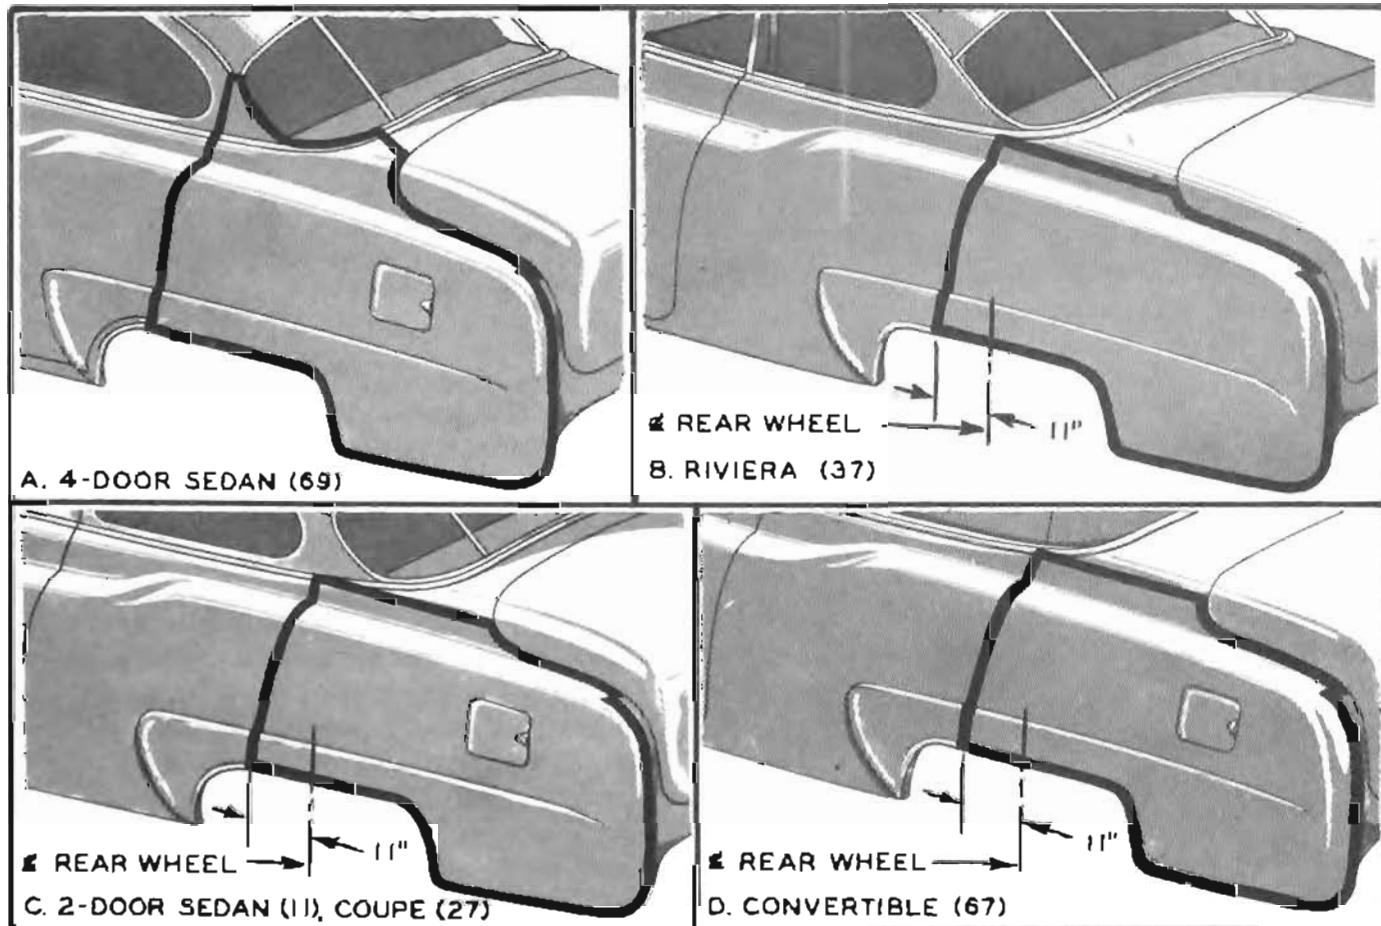
Figure 12-8—Four-Door Rear Quarter Side Outer Panel Application to Two-Door Models

The 4-door sedan (Style 69) rear quarter side outer panel is the most economical panel to use for replacement in the indicated area on any model. This panel is shown in figure 12-8, view A. Views B, C and D show the application of the interchangeable portion of this panel to the 2-door models. It is not necessary to replace the entire area indicated—only the damaged area need be replaced.

From lower edge to crown and to a vertical line approximately 11" forward of rear wheel centerline the contours of all *Series 40* rear quarter side outer panels are identical. A section cut from this area of any available

outer panel may be used for replacement of the corresponding section of panel on any *Series 40* model.
