SECTION 5-B

DYNAFLOW TROUBLE DIAGNOSIS—ADJUSTMENTS ON CAR

5-9 DYNAFLOW TEST AND INSPECTION

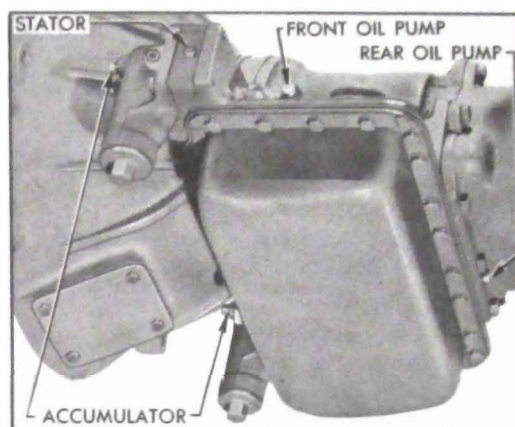
Figure 5-26—Gauge Connections for Oil Pressure Tests

Remove pipe plug at the following points in turn and connect Pressure Gauge J 2575. (1) *Front oil pump*, on left side of transmission case. (2) *Rear oil pump*, in lower flange at front end of rear bearing retainer. (3) *High or low accumulator*, on front upper corner of accumulator body. (4) *Stator*, on left end of reaction shaft flange. See figure 5-26.

Run engine at 500 RPM and test pump and accumulator pressures in Low, Drive and Reverse. Test front oil pump in all ranges and rear oil pump in all but Reverse. Test high accumulator only in Drive and test low accumulator only in Low. Repeat tests at 1000 RPM and 1800 RPM in Low and Drive only. The following pressures should be obtained on these tests.

Engine RPM	Trans. Range	Front Pump	Rear Pump	Accumulator	Stator (min.)
500	Low	120	90	115	10
	Drive	90	90	80	10
	Reverse	120	—	—	10
1000	Low	180	180	175	20
	Drive	90	90	85	70
1800	Low	180	180	175	100
	Drive	90	90	85	75

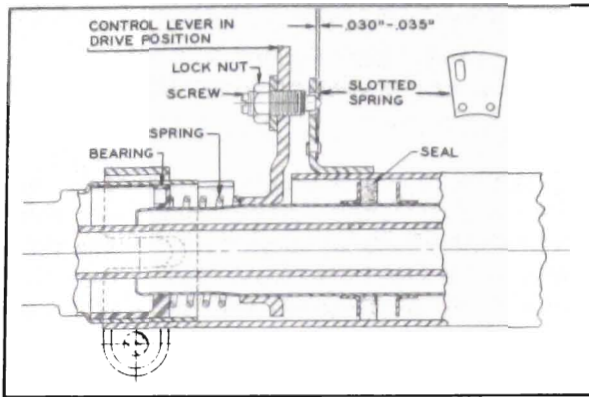
Figure 5-27—Lower Lever and Stop Plate

The shift lever operates a cross shaft inside the rear bearing retainer, from which linkages connect to the shift control valve and the parking lock pawl. A spring loaded detent lever and roller engages notches in a detent plate on the cross shaft to hold the control valve in any set position.
